Moorfield Car Park, Truro

Structural Assessment

Infra23-178-CSL-SGN-SW824447-RP-S-002

Mott MacDonald ref: 004STR-MMD-XX-XX-T-S-0003

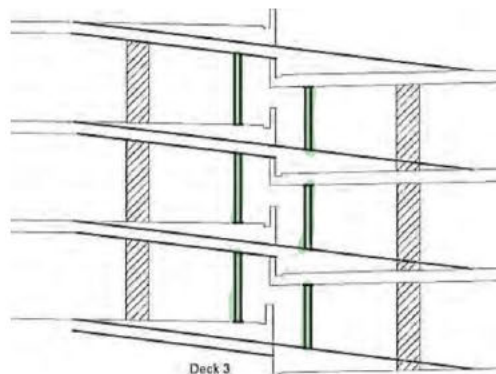
Figure 2.4 Ramp props

- 2.1.7 Deck 4 supports a small toilet block along its northern edge.
- 2.1.8 The structure is supported on piled foundations.
- 2.1.9 There are RC ramps providing access between the two halves of the structure. There are transverse “flexcel” joints at the centre of these ramps providing structural separation of the two halves of the car park.
- 2.1.10 In 2017/2018 steel props were added to the ramps

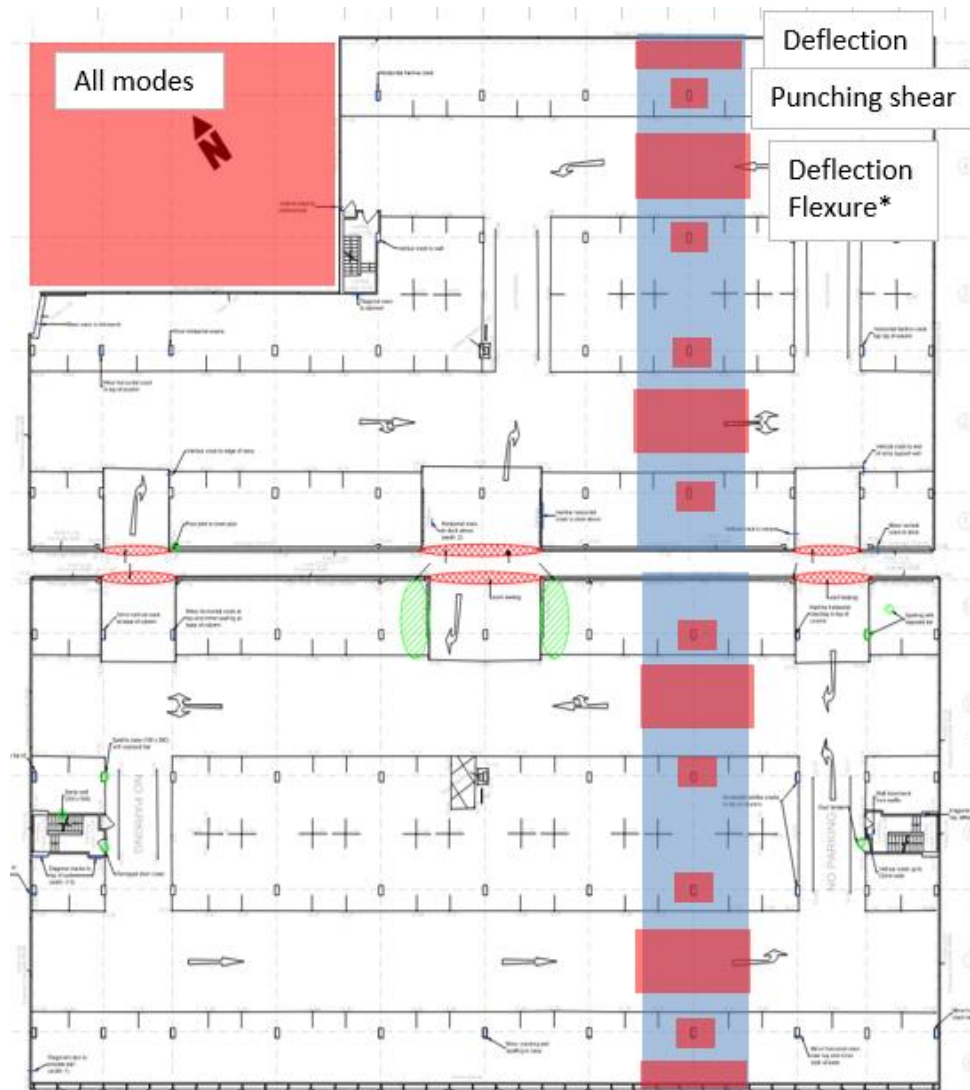
Figure 4.1 Visualisation of assessment

4.1.3 The exception to this was those under the plaza where the columns have a utilisation ratio higher than 1 in uniaxial and biaxial bending, which is considered as failed. These columns are subject to high moment effects. It is of note that these columns are also taller (4.7m) than the rest of the car park columns (2.6m).

4.3.1 A visual representation of the failure locations is shown in Figure 4.1.

*flexure failure only applies if there is one bar in each rib, it passes if there are two.
Visualisation overlain on previous inspection report sketch, ignore green and red hatches.

- 4.3.10 There is a potential concern regarding flexure in these 8.8m “end” spans as the site investigations identified some instances of ribs having only one 20mm bar in the bottom of the section instead of two. As identified in Table 4.2 & Table 4.3 if this is the case then the section has a utilisation greater than 1. Exact locations where there is only one bar have not been fully mapped and should it only apply to the shorter spans then the flexural failure would be removed. Investigation of these is recommended.

- Further non-destructive investigations (Ferroskan surveys) to determine the number of bars within the waffle slab ribs (to verify risk of flexural failure).

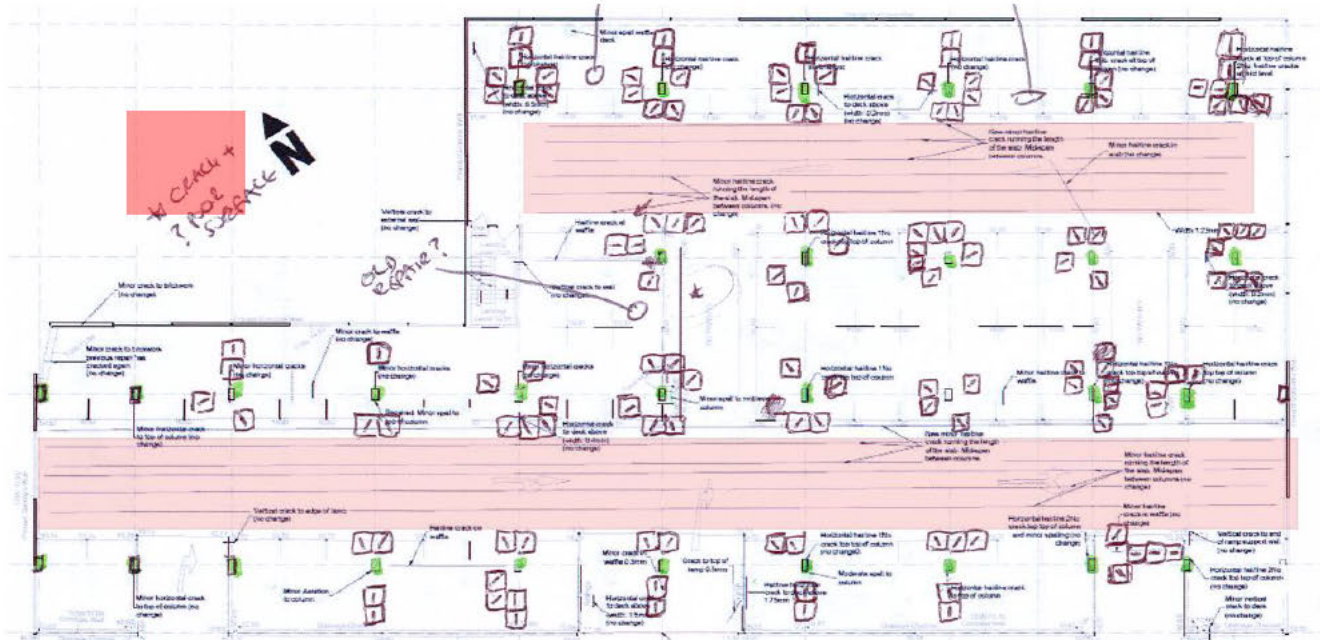
Figure 4.2 Deck 6 (underside of deck 8) inspection findings Nov 23.

- Cracking running longitudinally down the underside of deck 8 and 9. These cracks extend the majority of the length of the car park and occurs within the “end spans” (shown in red in Figure 4.2). This is noted as an area of concern in this assessment. This longitudinal cracking is not present within the lower decks at this time.
- Cracks extending radially from the column heads within the deck of the waffle section. This occurs around columns on all decks, with the

frequency and length greatest under the plaza and on the upper decks. This is noted as an area of concern in this assessment.

- Cracking within the soffit of the deck under the plaza, extending from the column heads. Cracks have evidence of water seepage and repairs.
- Areas of cracking / spalling on some columns and impact damage.
