Moorfield Car Park, Truro

Structural Assessment

Infra23-178-CSL-SGN-SW824447-RP-S-002

Mott MacDonald ref: 004STR-MMD-XX-XX-T-S-0003

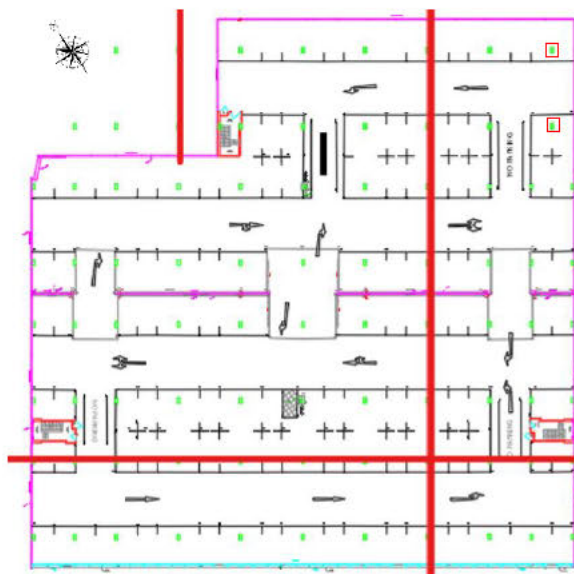
Figure 3.1 Location of slices

- 3.3.2 Sections were constructed in Autodesk Robot to calculate load effects and supplemented by excel and Tekla Tedds calculations.
- 3.3.3 Figure 3.1 shows the location of the three slices that are modelled (red lines), a transverse slice running approximately N-S, a transverse slice through the plaza and a longitudinal slice through E-W.

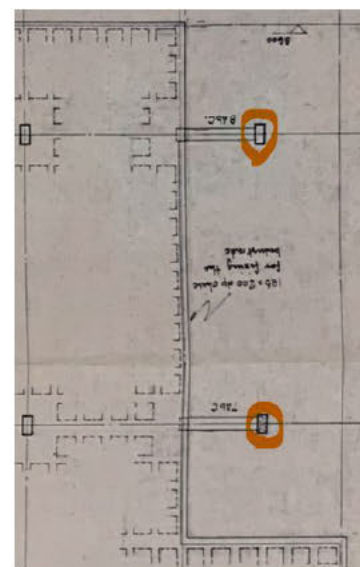
Figure 3.2 Level 1 columns

- 3.3.4 The assessment has been targeted in its approach to initial key areas to understand the capacity. A section has not been taken through the ramp, nor have the columns at the entrance to Deck 1 been considered (Figure 3.2). These columns differ from the others at Deck 1 as they continue to the underside of Deck 6 with beams connecting them to Deck 4. There is limited as built information for these beams and columns.

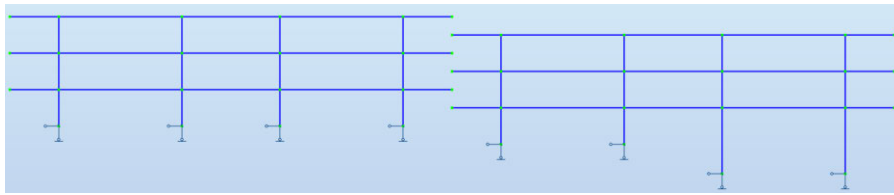
Figure 3.3 Idealised section

3.3.5 Figure 3.3 shows the transverse section in Autodesk Robot, the frame connections are fixed with pinned supports.

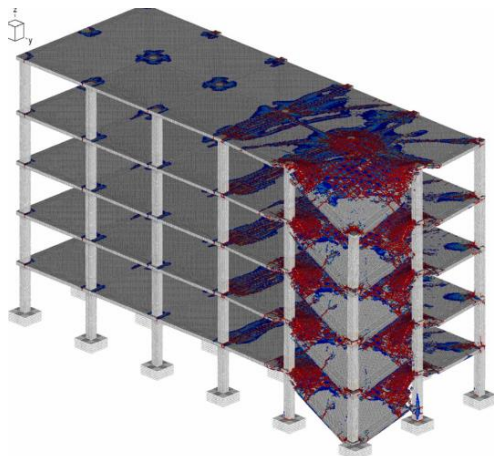
Figure 4.3 Progressive collapse example (theconstructor.org)

- 4.3.23 Progressive collapse
- 4.3.24 Analysis of progressive collapse has not been carried out as part of this assessment. However from a review of the form and known failure modes for these types of structures there is a risk of progressive collapse either vertically or horizontally through the car park, and example of which is shown in Figure 4.3.

- 4.3.26 Similarly, the failure could progress horizontally along the deck length, as the failure of the slab at one column increases the load at the adjacent column, causing a further punching shear failure.

- 4.3.27 Modern slab construction is typically designed with a minimum amount of tying reinforcement to increase resilience against this kind of failure. Due to the limited information it is not possible to determine if this has been included, and so there is a risk of progressive collapse if the potential failure modes are not mitigated.
